**Flood Control Project Maintenance  
Levee Inspections**

**Fall 2018 Levee Maintenance Deficiency Summary Report**

**Sutter Maintenance Yard Nelson Bend**

Waterway			Bank	Unit Miles
Unit No. 01 Feather River West Levee - Nelson Bend				0.50
	Spring (March - May)	Summer (June - August)	(September - November) Fall	Winter (December - February)
Unit Maintenance Rating (Fall Only)			<b>U</b>	
Date of Inspection	4/4/2018 - 4/4/2018		9/18/2018 - 9/18/2018	
DWR Inspector	Sterling York		Sterling York	
Accompanied By	Steve Beckley		Steve Beckley

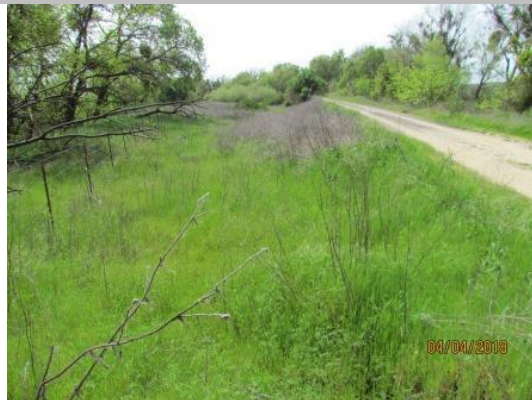
Photo 2 of 2 : FA\_2018\_ST0006\_471\_15\_20180918\_00006.jpg

LM Start	0.02	Rating **	U	Issue No.	15 (cont)	
LM End	0.42	Issue Type +	Ma	Location *	WS	
Category	Earthen Levee			GPS Latitude/Longitude		
				Start		End
Item	Vegetation			38.886883 °		38.881287 °
				-121.614797 °		-121.614490 °
DWR ID	DWR_ST0006_01_f_2015_15					
Comment Code						
V2 : Remove the wild growth other than native grasses from the levee slopes.						
Inspector Comment						
Remove the annual vegetation and wild growth. Fall 2018.

View of the vegetation along the waterside slope looking downstream, Spring 2018.

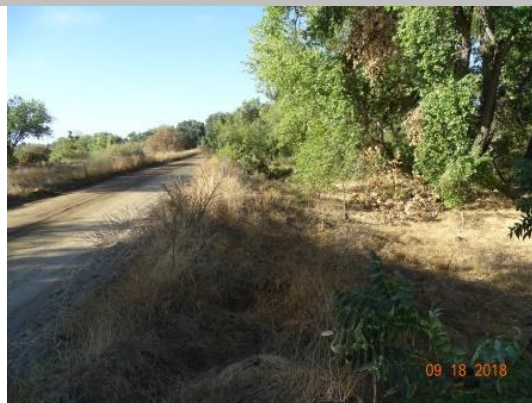
Photo 1 of 2 : FA\_2018\_ST0006\_471\_2\_20181003\_00015.jpg

LM Start	0.02	Rating **	U	Issue No.	2
LM End	0.46	Issue Type +	Ma	Location *	LS
Category	Earthen Levee			GPS Latitude/Longitude	
				Start	End
Item	Vegetation			38.886883 °	38.880833 °
				-121.614797 °	-121.614387 °
DWR ID	DWR_ST0006_01_f_2015_2				
Comment Code					
V2 : Remove the wild growth other than native grasses from the levee slopes.					
Inspector Comment					
Remove the annual vegetation and wild growth. Fall 2018.

View of the vegetation along the landside slope looking downstream, Fall 2018.

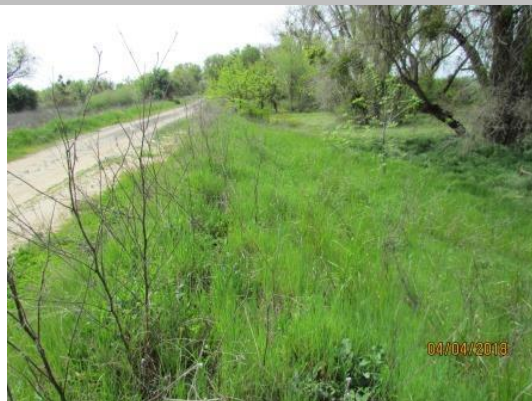
Photo 2 of 2 : FA\_2018\_ST0006\_471\_2\_20180918\_00002.jpg

LM Start	<b>0.02</b>	Rating **	U	Issue No.	<b>2 (cont)</b>
LM End	<b>0.46</b>	Issue Type +	Ma	Location *	LS

View of the vegetation along the landside slope looking downstream, Spring 2018.

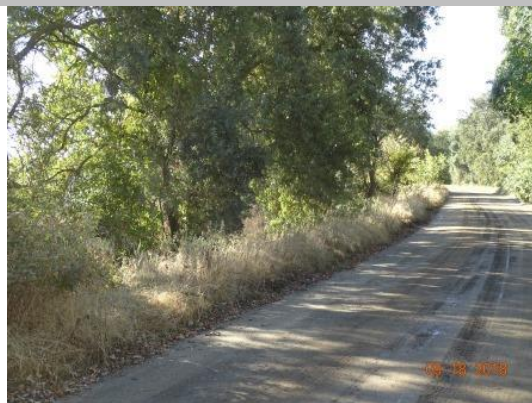
Photo 1 of 2 : FA\_2018\_ST0006\_471\_1\_20181003\_00016.jpg

LM Start	0.13	Rating **	U	Issue No.	1
LM End	0.50	Issue Type +	Ma	Location *	WS
Category	Earthen Levee			GPS Latitude/Longitude	
				Start	End
Item	Trim / Thin Trees			38.885396°	38.880295°
				-121.615595°	-121.614147°
DWR ID	DWR_ST0006_01_f_2017_1				
Comment Code					
T3 : Trim and thin trees to allow visibility of the ground and room to flood fight.					
Inspector Comment					
Trim up the trees 5 feet for access and visibility, Fall 2018.

View looking downstream waterside of the over growth of trees, Fall 2018.

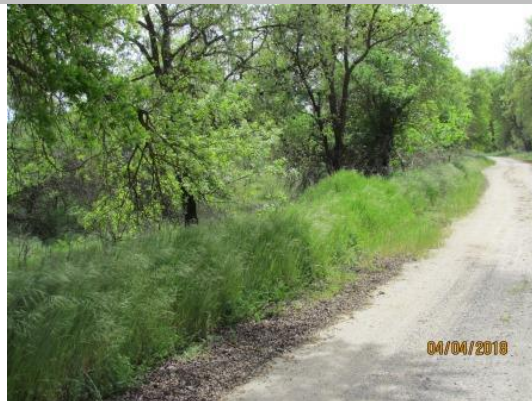
Photo 2 of 2 : FA\_2018\_ST0006\_471\_1\_20180918\_00001.jpg

LM Start	<b>0.13</b>	Rating **	U	Issue No.	<b>1 (cont)</b>
LM End	<b>0.50</b>	Issue Type +	Ma	Location *	WS

View looking downstream waterside of the over growth of trees, Spring 2018.

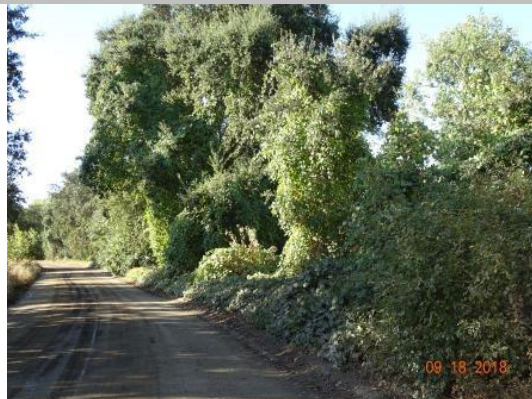
Photo 1 of 2 : FA\_2018\_ST0006\_471\_3\_20181003\_00017.jpg

LM Start	0.13	Rating **	U	Issue No.	3
LM End	0.50	Issue Type +	Ma	Location *	LS
Category	Earthen Levee			GPS Latitude/Longitude	
				Start	End
Item	Trim / Thin Trees			38.885396 °	38.880295 °
				-121.615595 °	-121.614147 °
DWR ID	DWR_ST0006_01_f_2017_3				
Comment Code					
T3 : Trim and thin trees to allow visibility of the ground and room to flood fight.					
Inspector Comment					
Trim up the trees 5 feet for access and visibility, Fall 2018.

View looking downstream landside of the over growth of trees, Fall 2018.

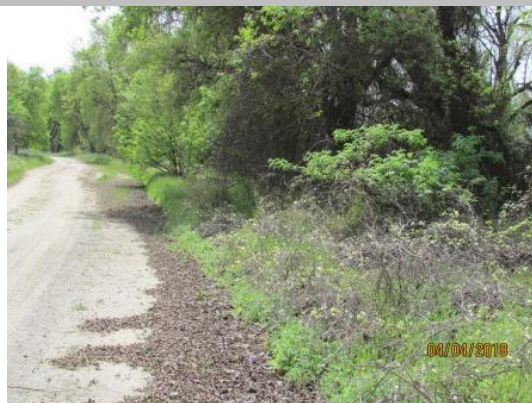
Photo 2 of 2 : FA\_2018\_ST0006\_471\_3\_20180918\_00003.jpg

View looking downstream landside of the over growth of trees, Spring 2018.

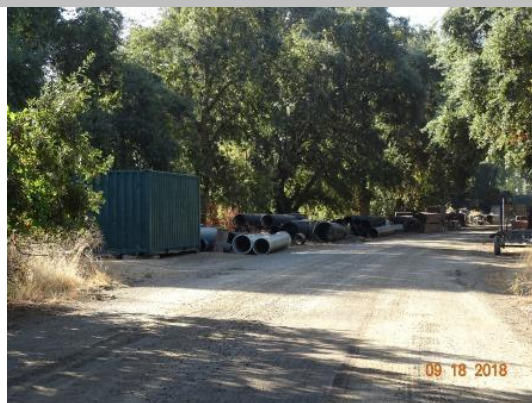
Photo 1 of 2 : FA\_2018\_ST0006\_471\_16\_20181003\_00018.jpg

LM Start	0.40	Rating **	U	Issue No.	16
LM End	0.46	Issue Type +	En	Location *	WS
Category	Earthen Levee			GPS Latitude/Longitude	
				Start	End
Item	Encroachments			38.881638 °	38.880795 °
				-121.614647 °	-121.614427 °
DWR ID	DWR_ST0006_01_f_2015_16				
Comment Code					
DE : Debris					
Inspector Comment					
The large pipe is still laying along the waterside berm, Fall 2018.

View of the pipes and new c-container along the waterside shoulder looking downstream. Fall 2018.

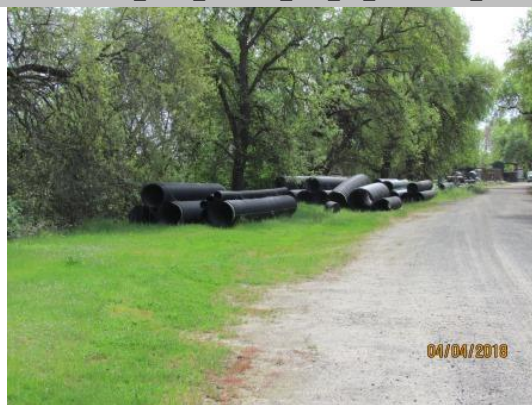
Photo 2 of 2 : FA\_2018\_ST0006\_471\_16\_20180918\_00007.jpg

LM Start	<b>0.40</b>	Rating **	U	Issue No.	<b>16 (cont)</b>
LM End	<b>0.46</b>	Issue Type +	En	Location *	WS

View of the pipes along the waterside berm looking downstream. Spring 2018.

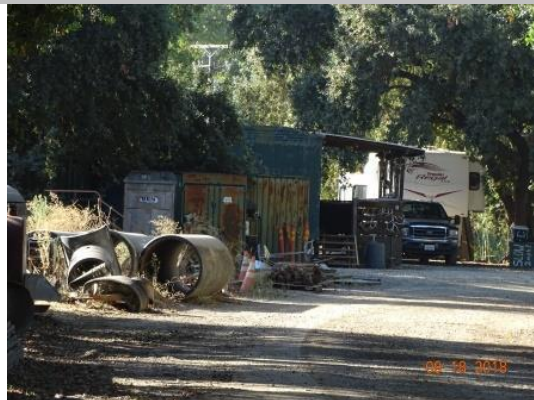
Photo 1 of 2 : FA\_2018\_ST0006\_471\_8\_20181003\_00019.jpg

LM Start	0.47	Rating **	U	Issue No.	8
LM End	0.47	Issue Type +	En	Location *	CR
Category	Earthen Levee			GPS Latitude/Longitude	
				Start	End
Item	Encroachments			38.880664 °	38.880664 °
				-121.614335 °	-121.614335 °
DWR ID	DWR_ST0006_01_s_2012_8				
Comment Code					
BU : Building					
Inspector Comment					
The building is directly behind the pipes that are laying along the waterside berm. Fall 2018.

View of the building directly behind the pipes on the waterside berm looking downstream. Fall 2018.

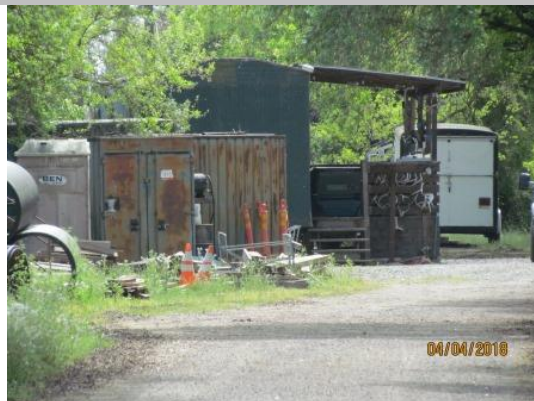
Photo 2 of 2 : FA\_2018\_ST0006\_471\_8\_20180918\_00005.jpg

LM Start	<b>0.47</b>	Rating **	U	Issue No.	<b>8 (cont)</b>
LM End	<b>0.47</b>	Issue Type +	En	Location *	CR

View of the building directly behind the pipes on the waterside berm looking downstream. Spring 2018.
